MEMORANDUM

Project: Gold King Interim Water Treatment Plant (IWTP)

Reporting Period: Aug 15 – Aug 22

Report No.: 33

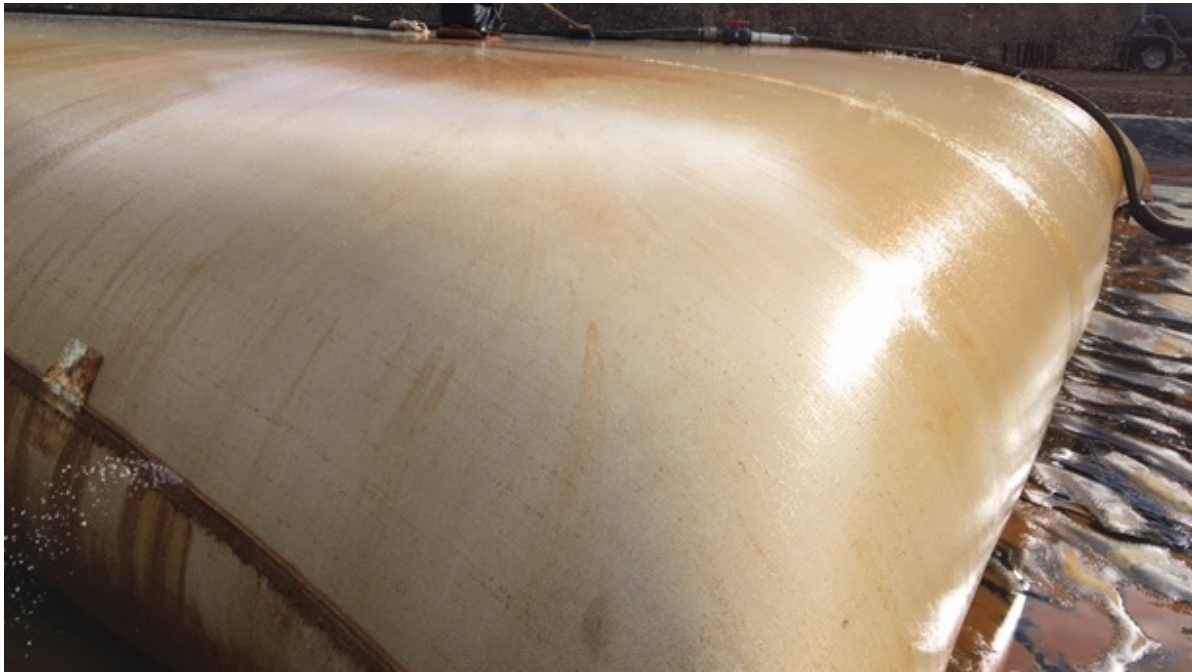
- There is concern that the A and B bags are full, and Alexco is currently filling bag C at times to allow the other bags to dewater. Alexco will continue to minimize bag C usage while focusing on utilizing the bags A and B throughout the remainder of August.

Photo 1: Bags in the A and B cells are full, but continuing to dewater.

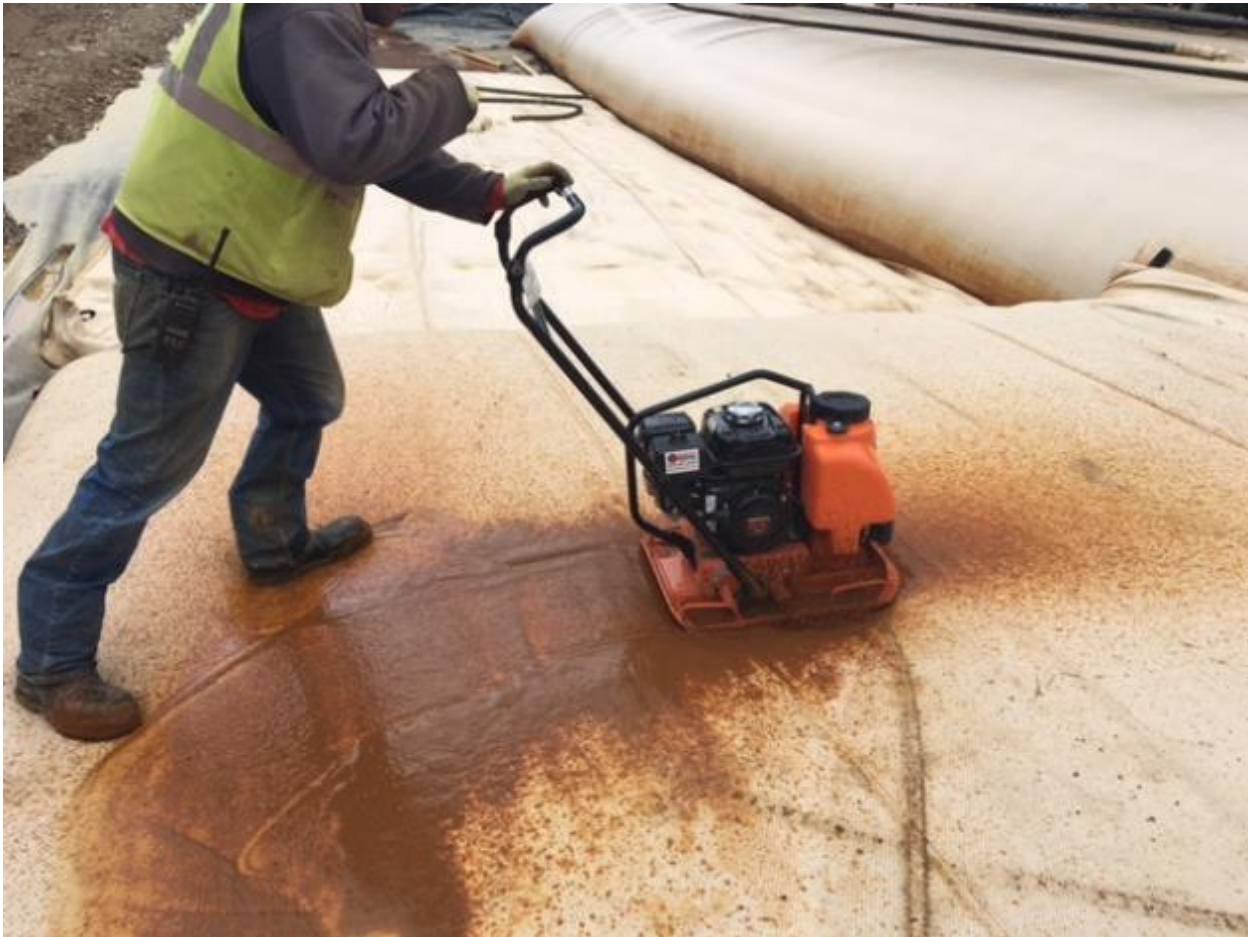
Photo 2: A plate compactor was tested to see if additional energy improved dewatering. There was an initial release, but it did not make any longer term improvements in dewatering.

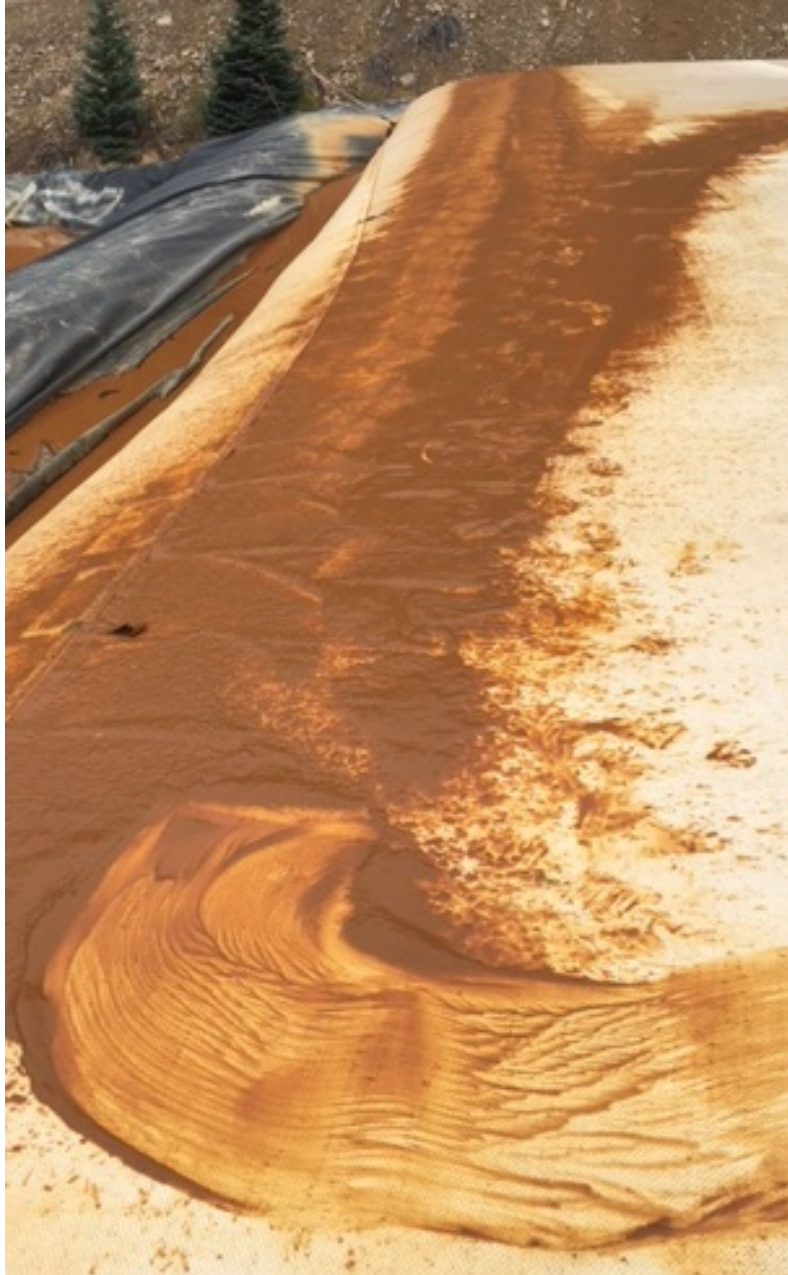
Photo 3: The plate compactor created an accelerated release of water and micro-sludge from the bag.
